Manhole Inspection Summary

Manhole # S27C__029MH

Location Address: **725 CHERRY BLOSSOM WAY** Cross Street: **MULBERRY ST**

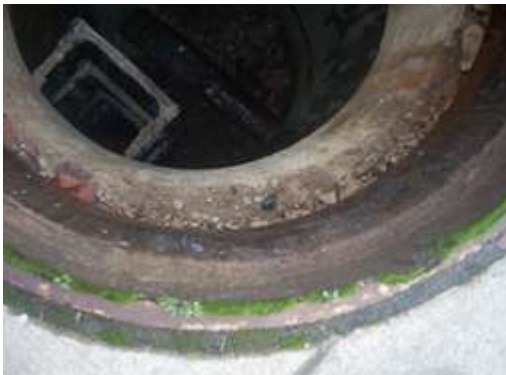
Defect 2

Frame Offset: **2** (in.) Condition: ☒ Sound ☐ Cracked ☐ Leaks

FRAME OFFSET

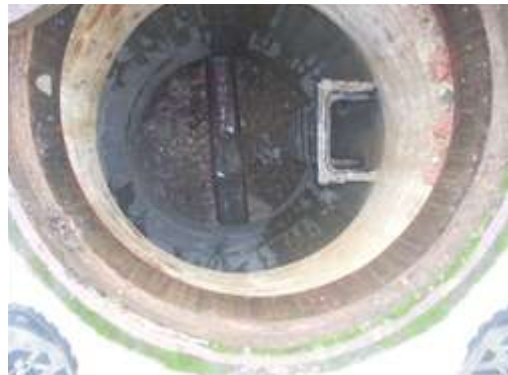
Defect 3

Channel Material: **Brick** ☐ Parged
Channel Exposure: **Fully Open** Junc Dist: **0** nearest .5 ft. Azimuth:
Condition: ☐ Sound ☐ Cracked ☐ Root Intrusion ☐ Deteriorated ☐ Leaks ☒ **Debris**

CHANNEL DEBRIS

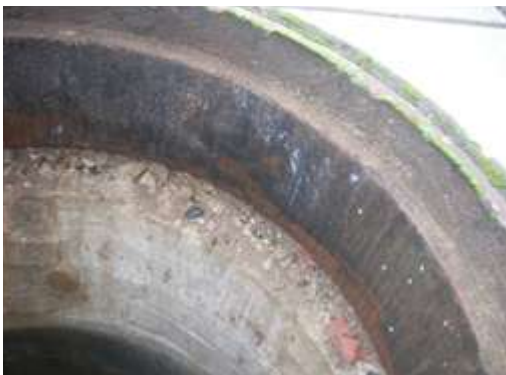
Defect 1

Chimney / Frame Adjustment ☒ Exists Material: **Brick** ☐ Parged Height: **3** (in.)
Condition: ☐ Sound ☐ Cracked ☐ Root Intrusion ☐ Loose Brick ☒ **Deteriorated**
Infiltration: ☐ None ☒ **Joint** ☐ Cracks ☐ Mortar ☐ Roots ☐ Wall

CHIMNEY DETERIORATION AND INFILTRATION

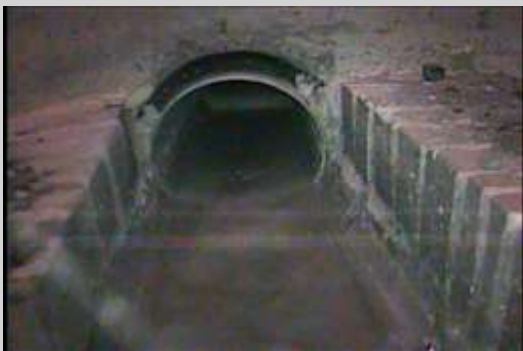
6 O'Clock Inflow

PIPEMAY NOT FIT PROPERLY
